THE ROLE OF GEOTECHNICAL FACTORS IN NORTHRIDGE EARTHQUAKE RESIDENTIAL DAMAGE

ABSTRACT

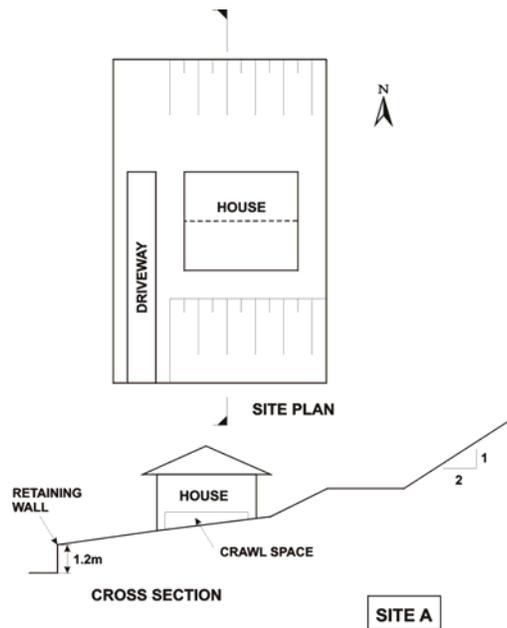
Fig. 4. Representative Hill-Side Site

The house is a single-story wood-framed structure founded on perimeter and interior concrete stem walls with cripple walls and isolated interior footings consisting of concrete pedestals, wooden caps, and wooden posts. The house was constructed circa 1920. An approximate location of the property is indicated in Figure 3 (Case History "A"). A plan view and a cross section through the property are shown in Figure 4.

According to the property owner, as a result of the earthquake, the stem walls cracked, the floor level was "changed," the flatwork cracked, the front retaining wall broke and leaned over, the exterior stucco cracked, and interior wall and ceiling finishes were damaged. According to the property owner, after the earthquake, new stem walls were installed on the north and east sides on the house, floors were re-leveled, and some stucco and interior surface cosmetic damage was repaired.

Based upon the property owner interview and our observation of site conditions, we concluded that there was no plausible geotechnical mechanism by which the earthquake caused a change in the bearing capacity of the soils at this site, the ability of the soils to support the house foundations, or of the rate of soil creep at the property. We recognized that the damage to the front retaining walls, and increase of moisture ingress through cracked flatwork, and leaking pipes were earthquake impacts that could, however, have resulted in increased localized soil creep. In conjunction with a structural engineer, we concluded that the stem wall cracks predated the earthquake and that both the stem wall cracking and pre-earthquake soil creep probably rendered the house susceptible to earthquake-induced structural and cosmetic damage. Furthermore, replacement of the downslope stem wall after the earthquake probably introduced a relatively rigid and unmovable foundation member that caused further cosmetic damage to the house. A subsequent visit revealed that cracked foundations continued to move downslope and push the house flooring and other structural components against the relatively unyielding components above the new stem walls.

Some of the conditions at this property were typical of many we saw where long-term slope creep had affected the position and level of the house and the integrity of foundation components. In the earthquake, such structures were more vulnerable than otherwise to seismic-induced disturbance as a result of their distortion and compromised foundations. In many cases post-earthquake soil creep appeared to have been accelerated by leakage from pipes broken by the earthquake, cracked flatwork and retaining walls, and the fact that post-earthquake precipitation was generally higher than in the decade or so before the earthquake. We also saw properties where post-earthquake partial replacement of old or

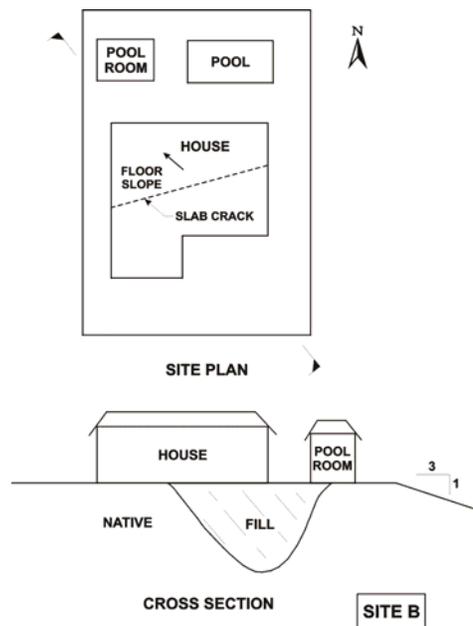
Fig. 5. Representative Cut/Fill Transition Site

The house is a single-story wood-framed structure constructed in 1957. The house foundation is a concrete perimeter footing and concrete slab-on-grade floor. An approximate location of the property is indicated in Figure 3 (Case History “B”). A plan view and a cross section through the property are shown in Figure 5.

The property owner told us that the house floor became unlevel as a result of the earthquake, that the courtyard paving to the north of the house was “deformed” after the earthquake, and that the pool shell “went down” to the southwest as a result of the earthquake. We lifted the carpets throughout the house during our site visit to inspect the slab-on-grade floor. In the west bedroom that straddles the reported change of grade of the floor, we observed a 10 to 15-mm wide crack with up to 5 mm of vertical offset across the crack. The crack had been filled with what appears to be a mortar grout; the grout filling had been placed in such a way to smooth out the vertical offset. The crack appeared to have opened no more than about 5 mm since the filling was placed. We noted that the slab crack appears to line up with the tile cracking in the entryway and the general floor slope changed along the slab crack.

On the basis of the property owner’s statement that the carpets had been installed before the earthquake and not subsequently lifted, we concluded that the slab cracking clearly predated the earthquake and similarly that the slope of the floor to the northwest of the crack also predated the earthquake. On the basis of the reported cosmetic cracking of the tiles and wall

finishes in the earthquake, we believe that some transient and possibly permanent fill deformation occurred as a result of the earthquake, but that this earthquake-induced deformation was not the predominant cause of the unlevel floors, the floor slab crack, or the vertical offset across the crack. We believe that the greater part of fill settlement and floor slope was the result of fill consolidation following original house construction.

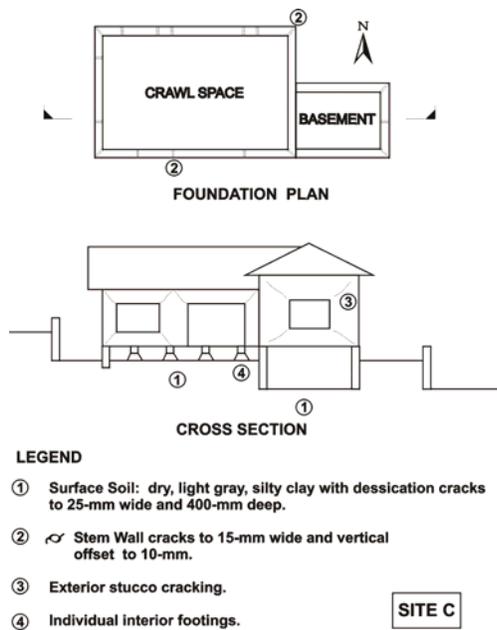
Fig. 6. Representative Site on Expansive Soils

The house is a single-story wood-framed structure founded on perimeter and interior concrete stem walls with cripple walls and isolated interior footings consisting of concrete pedestals, wooden caps, and wooden posts. The house was constructed circa 1950. An approximate location of the property is indicated in Figure 3 (Case History “C”). A plan view and a cross section through the property are shown in Figure 6.

We noted a direct correlation between the presence of expansive soils ($EI \geq 75$) and damage to the structure and finishes of the house. At this site and many others that we

visited that are founded on expansive soils, we noted significant stem wall cracking, deformation of the stem walls, and a correlation between reported interior cosmetic damage and the more desiccated soils at the site. For example, at the property shown in Figure 6, the structure and cosmetic finishes over the crawl space and particularly the north stem walls were significantly damaged in the earthquake.

The soil we observed beneath the stem walls of this house were dry and extensively desiccation cracked; the cracks were as wide as 25 mm, as deep as 400 mm, and were generally spaced at between 150 and 200 mm. It is as though the concrete stem walls were sitting on a series of isolated soil columns. Clearly, the long-term soil desiccation-induced deformation had stressed and in many instances cracked and displaced the stem walls relative to each other.

At this house, as at many we visited that are founded on expansive soils, the property owner had undertaken post-earthquake repair of cosmetic finishes only to be frustrated by the recurrence of stucco cracks, drywall plaster cracking, and deformed moldings. Obviously, ongoing seasonal soil swelling and shrinkage continue to move the foundations and to affect the structure and its cosmetic finishes. This process is exacerbated by the tendency to patch stucco and drywall cracks rather than remove and replace them – with even minimal seasonal movement of the foundation soil, the crack location makes itself known through paint and other overlays.

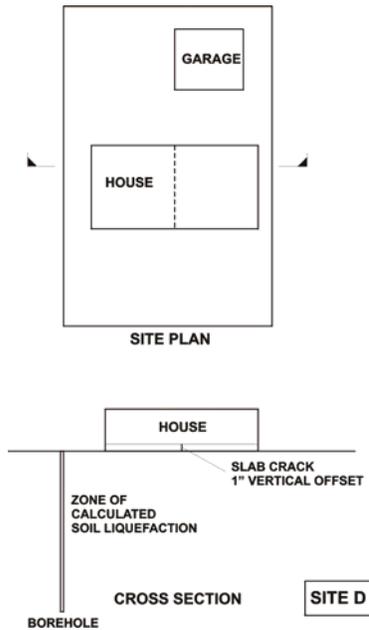
Fig. 7. Representative Site on Liquefied Soils

The house is a single-story wood-framed structure constructed between 1950 and 1960. The house foundation is a concrete perimeter footing and concrete slab-on-grade floor. An approximate location of the property is indicated in Figure 3 (Case History “D”). A plan view and a cross section through the property are shown in Figure 7.

The property owner told us that he was sitting in the living room at the time of the earthquake, unable to sleep because of back pain. He told us that in the earthquake the living room floor appeared to “plunge and snap.” He said that the width of the crack in the floor slab was about 50 mm immediately after the earthquake but appeared to close to about 30 mm in the days following the earthquake. Other earthquake damage described by the property owner included broken windows and door, cracking of exterior and interior wall finishes, and a significant “tilting” of the bathroom. He noted that as a general observation “most things fell to the south.”

When we observed the crack its width was about 30 mm and the vertical offset across the crack was about 25 mm, with the north slab segment being higher than the south slab segment. We observed that house floor slab to the north of the living room floor crack was generally level. The floor slab to the south of the crack generally slopes down to the south at an inclination of approximately one vertical in 100 to 200 horizontal. Laboratory testing of soil samples from test pits indicated that the upper site soils are silty sand with a unit

weight ranging from 14.6 to 16.5 kN/m³. Boreholes indicate that the local water table is about 5 m below the surface and that the soils to about 20 m are interbedded silty sand and sandy silt. Soil liquefaction-induced sand boils were observed in relative vicinity of the site (see Figure 3). A site-specific soil liquefaction analysis showed that two 1.5-m thick layers at about 10 and 15 m below the ground surface may have liquefied in the earthquake and the estimated site-specific PHGA of 0.62 g. Calculations indicated that up to 74 mm of liquefaction-induced soil settlement could have occurred at the site.

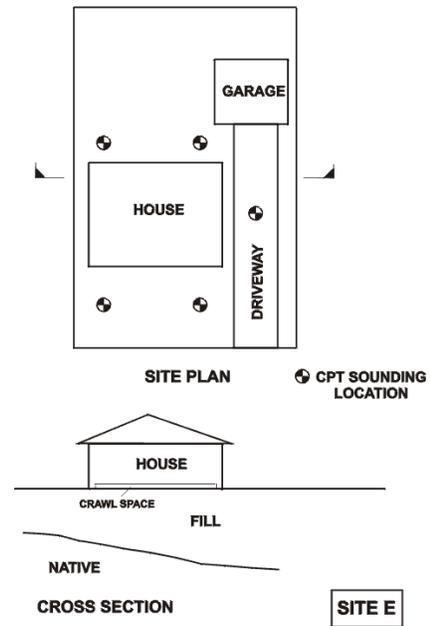
Fig. 8. Representative Site on Deep Fills of Variable Depth

The house is a single-story wood-framed structure constructed in 1924. The house foundation was originally cast-in-place concrete slab on grade, large parts of which had been removed in 1960 and replaced with Concrete Masonry Unit (CMU) perimeter and interior footings. An approximate location of the property is indicated in Figure 3 (Case History “E”). A plan view and a cross section through the property are shown in Figure 8.

This house was unlevel, the walls tilted, and the ceilings sloped in the same direction and to the same degree as the floors. We advanced five CPT soundings with *discrete soil sampling*TM. This established the upper three to five feet of soil was a variable mix of clayey silt and sand. Beneath this was a soft clay layer that varied from 5-m deep on the north side of the house to 8-m deep on the south side of the house. We concluded that the house had probably experienced considerable differential settlement ever since construction and that the Concrete Masonry Unit (CMU) stem walls had been installed before the earthquake in an attempt to correct house tilting. We believe that there was no significant earthquake-induced soil deformation at this site.
