The abatement of pollution from abandoned gold-residue dams

by G. E. BLIGHT* and J. A. CALDWELL†

This paper describes the development of geotechnical measures for the abatement of air and water pollution from abandoned gold-residue dams in the Witwatersrand area. The measures include the stabilization of the surfaces of the dams to prevent wind and water erosion, the terracing of slopes to minimize erosion, and the construction of catchment walls and dams.

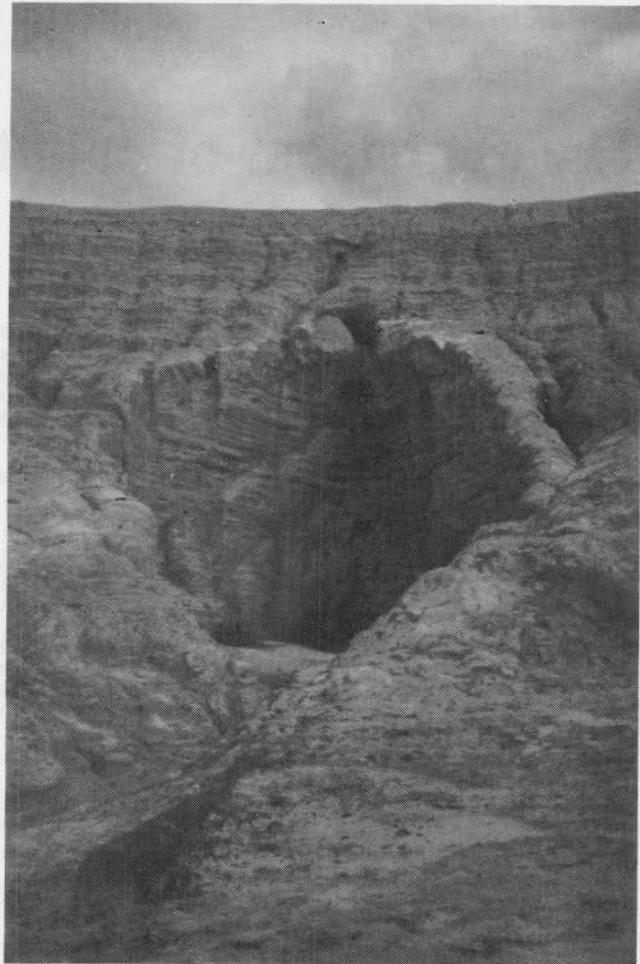
Fig. 1—Severe erosion caused by the collapse of steel penstock and delivery pipes buried in the residue. Voids left by a number of such pipes are visible

The penstocks used to decant water during the operation of a residue dam are plugged when the dam is closed because they otherwise tend to collapse and provide channels for piping erosion. Old dams often have a number of steel delivery or penstock pipes buried in them at various positions. The steel has usually corroded away and the resulting void been enlarged by erosion. Such a collapsed pipe can result in severe erosion, as illustrated in Fig. 1.

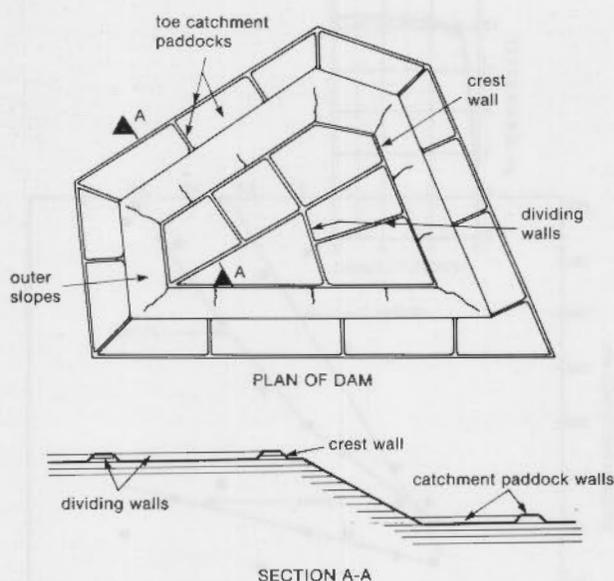
Fig. 2—Diagram showing measures taken to minimize water erosion of abandoned tailings dams

Fig. 2 shows diagrammatically some of the features mentioned above, while Fig. 3 shows the crest and dividing walls on the top of an abandoned dam. (Note the urban development surrounding the dam and the severe surface erosion in the foreground.)

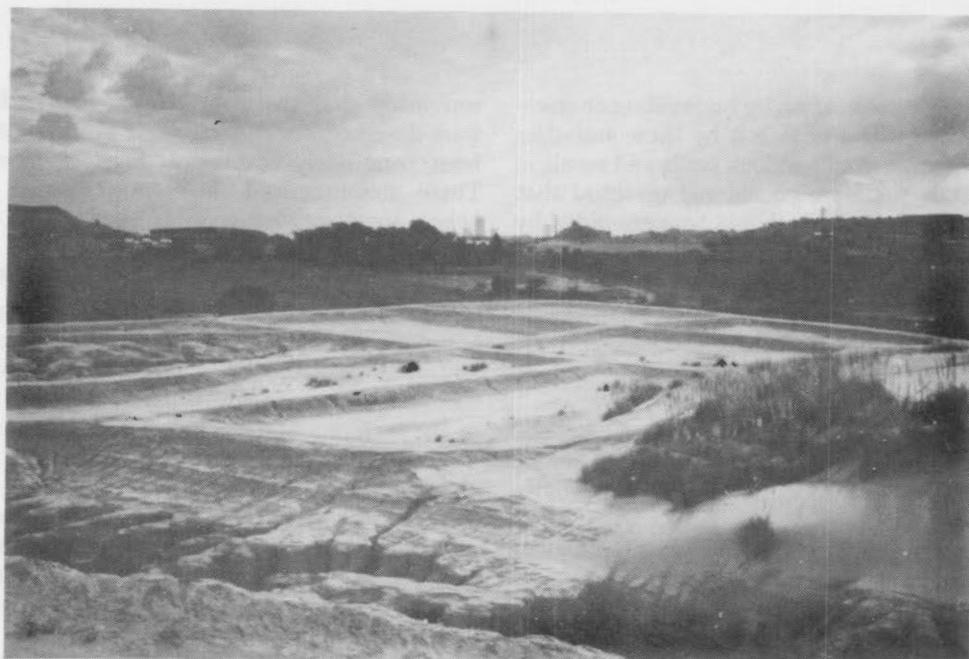
Fig. 3—Abandoned tailings dam provided with crest and dividing walls

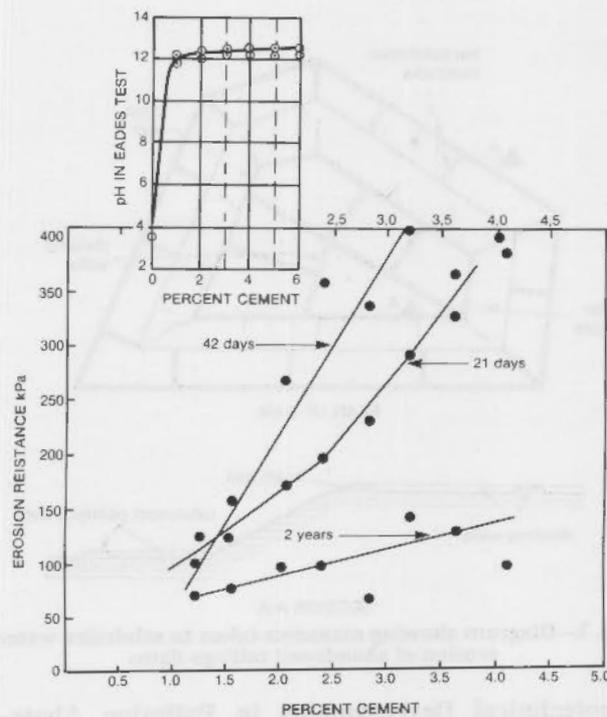
Fig. 4—Results of tests on the stabilization of gold residue with Portland cement

Fig. 4 shows the measured erosion resistance plotted against percentage cement at times of 21 days, 42 days, and 2 years after stabilizing. It became apparent from these results that (at least in the early ages) cement was more effective than lime, and it was decided that the top surfaces of a number of tailings dams should be stabilized with cement (3 per cent) to a depth of 75 mm, and that the performance of these surfaces should be observed over a number of years. Twelve tailings deposits were stabilized in this way.

The test results in Fig. 4 show a considerable decrease in Comet readings after 2 years. The decrease can be attributed to at least two causes:

- (i) the attack on the cement by sulphates proved to be more severe than expected; and
- (ii) soluble salts, drawn to the surface by evaporation gradients and crystallizing out at the surface, disrupted material at the surface.

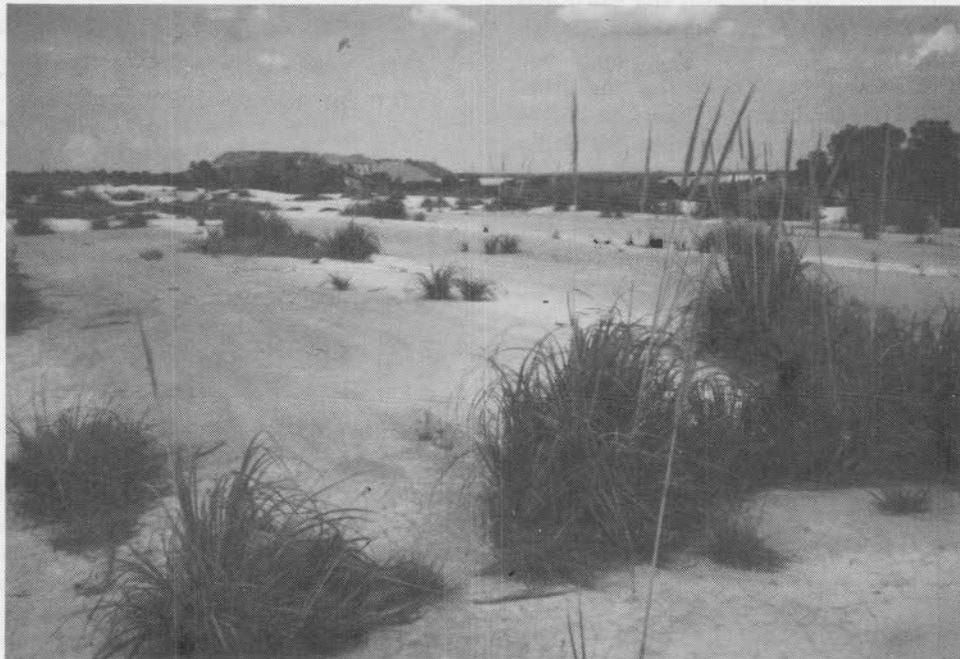
Fig. 5—Appearance of test panels of stabilized gold residue three years after laying

produced by a pneumatic compactor appears to deteriorate less than the rough, indented surface left by a tamping compactor. Fig. 5 shows the surfaces of the original test panels three years after being laid. The unstabilized strips between the panels show up as a result of their lighter colour. Even though the Comet resistance of the panels is low, they now stand proud of their surroundings, showing that they are more erosion-resistant than the unstabilized surfaces.

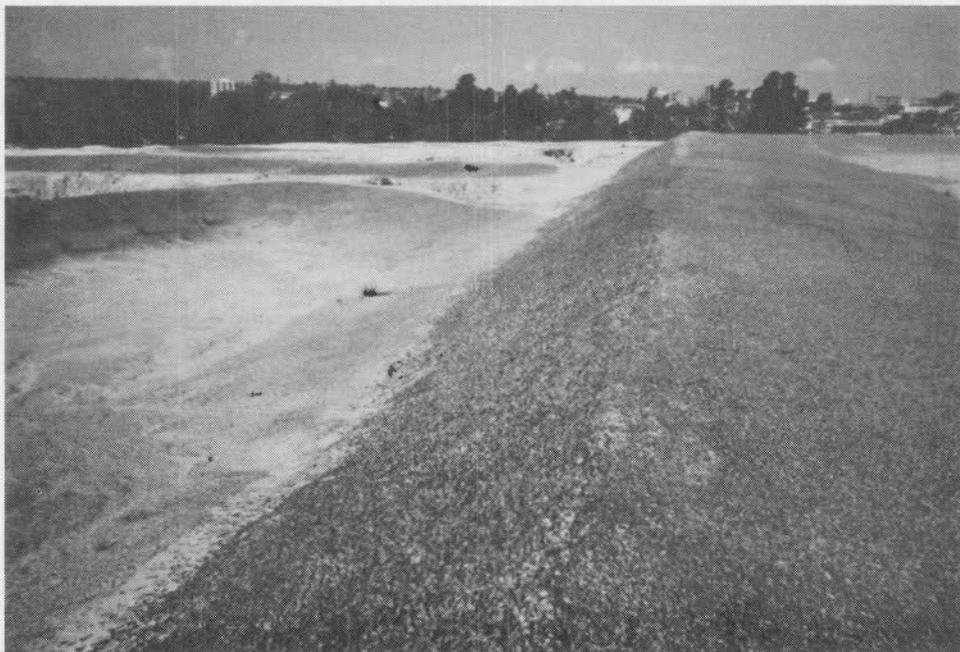
Fig. 6—Appearance of paddock walls protected against wind and water erosion by a single layer of 19 mm of crushed-stone chips. Photograph taken two years after laying

large dune that threatened to move into the town was successfully halted after its surface had been covered with power-station cinders. The layer was thin, only one particle thick, but successfully prevented the wind from picking up the underlying sand, thus halting the movement of the dune. This technique was tried on the slopes of the paddock walls of one of the twelve treated dams. There, a single-particle layer of 19 mm crushed-stone chips was spread on the slopes. Two years later, the treatment appears to have been very successful, with little evidence of the displacement of the stone or the underlying slimes by water or wind. Fig. 6 shows the appearance of this treatment two years after its application.

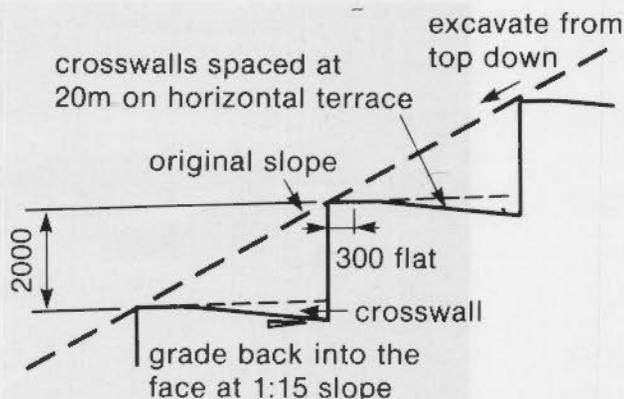
Fig. 7—Design section for terraced slope shown in Fig. 8

tailings deposits, these faces appeared to be unaffected by erosion. The same phenomenon has been observed in natural vertical slopes. It was therefore decided that an experiment should be carried out in which the slope of a tailings deposit is terraced into a series of vertical faces separated by approximately horizontal steps or berms. To retain the precipitation, the berms are sloped back towards the dam, and are sub-divided at intervals by cross-walls so that all the precipitation on the berms is held and allowed to evaporate. Fig. 7 gives a design section of a terraced slope, and Fig. 8 shows an experimental terraced slope three years after the terraces were cut.

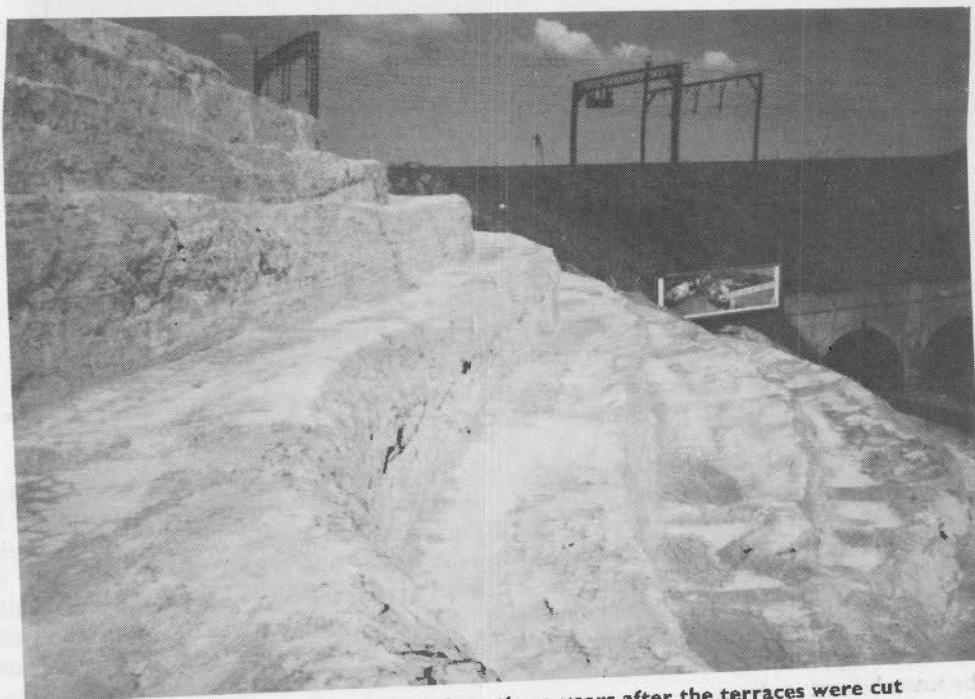
Fig. 8—Experimental terraced slope three years after the terraces were cut

The state of these terraces is extremely good. In all cases very little erosion of the vertical faces has occurred, and in many cases a hard, dry crust has formed on the vertical face. Some eroded slime has accumulated in the paddocks formed by the back-sloping benches, and in a few instances exceptionally heavy rain has resulted in

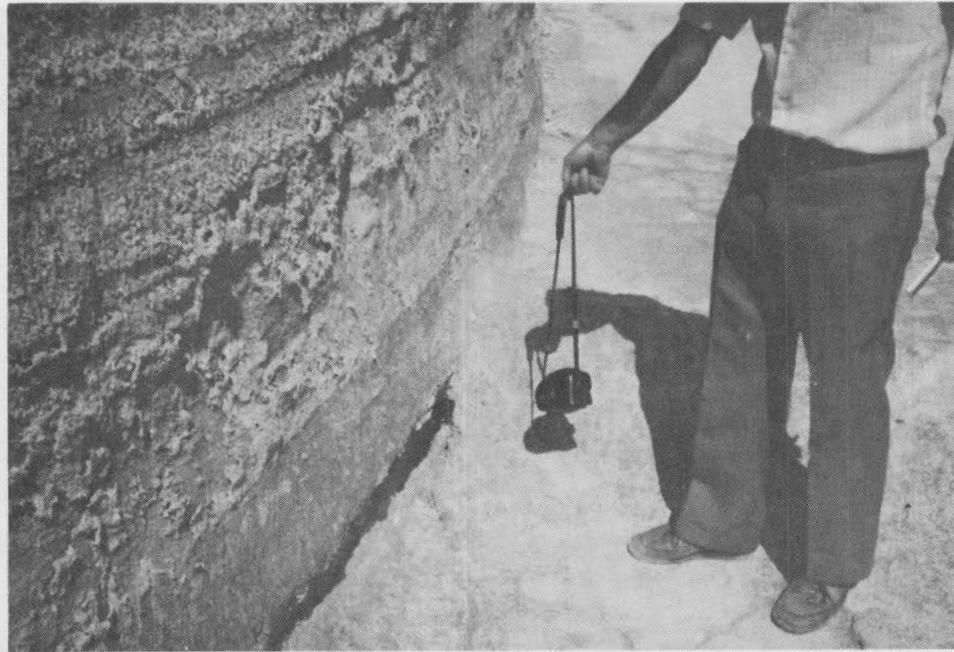
Fig. 9—Vertical face of a terrace taken three years after the terrace was cut

overtopping of the benches. Fig. 9 is a close-up view of the vertical face of a terrace, showing the excellent condition of the surface.

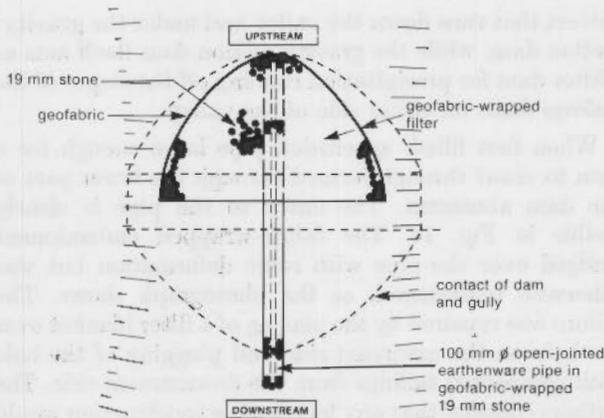
Fig. 10—Plan showing details of a filter dam

Run-off from tailings deposits that is polluted by material eroded from the deposit is retained at strategic positions by dams designed to retain the silt content of the run-off while allowing clear water to seep away. Although this water is clear, it contains dissolved solids, and only one component of pollution is removed. Fig. 10 shows typical details of such a filter dam. The upstream slope of the dam is underlain by a filter blanket that acts as a collection drain and filter for the polluted water retained behind the dam. After entering the filter blanket, the water gravitates to the central collector drain and is allowed to escape downstream. Fig. 11

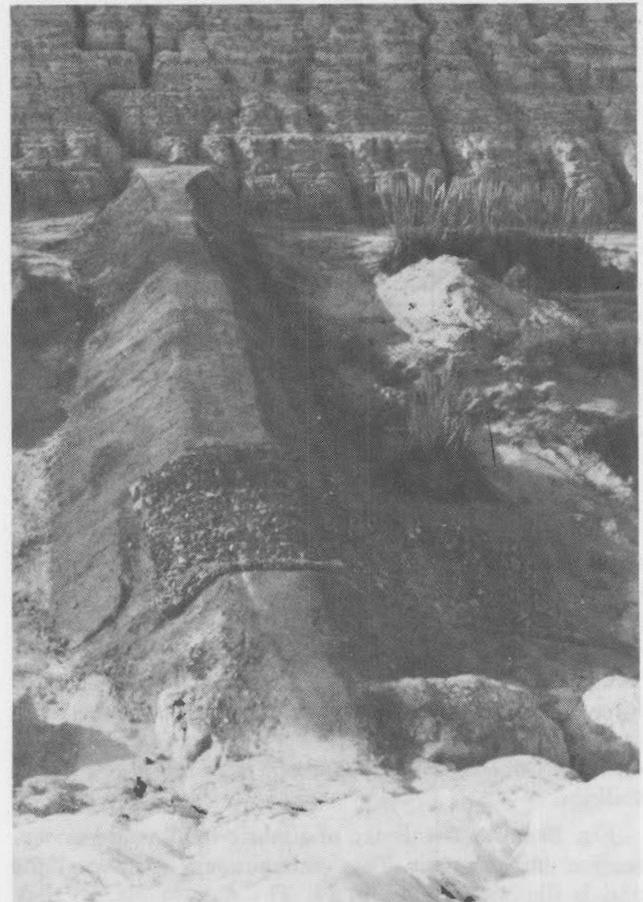
Fig. 11—Appearance of a filter dam with an emergency spillway

shows one of these dams, together with its emergency spillway, protected from erosion by means of a gabion mattress.
